Marine Incidents in Victoria

Fatal Incident in Port Phillip Bay

Involving Recreational Vessel “Adams Den”

Coroner’s Case No. 1505/04

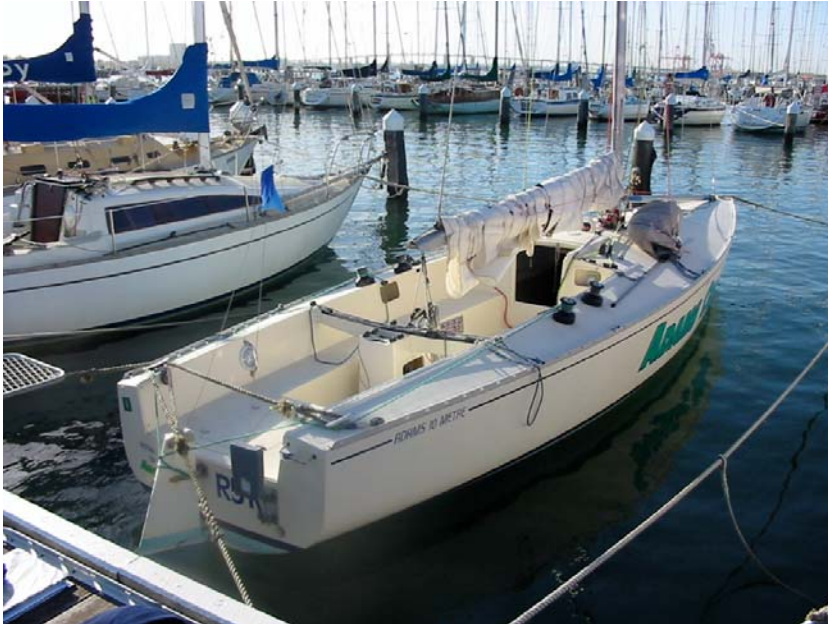
Vessel type - Adams 10 sailing yacht

From the above picture, the following should be noted:

(a) The open nature of the vessel with no guardrails or handholds and low foot rails, having a very large cockpit area, open to the sea at the stern. These provide minimal restraint to prevent a crewmember going overboard if losing balance or stumbling etc.

Factor 4.1 (a) the design and outfit of the vessel (no guardrails or handholds) provided inadequate restraint to prevent crew members going overboard.

It is recommended that yachting authorities review the requirements of YA Special Regulations for Category 5 equipment, Section 3.11 “Lifelines, Stanchions and Pulpits” and Section 3.12 “Toe Rails” which for Category 5 are currently only “recommended”. Section 3.17 “Hand Holds” which currently refers to below decks only, should also be expanded to include above deck use, the objective being to provide the boat with a greater degree of man overboard prevention measures.

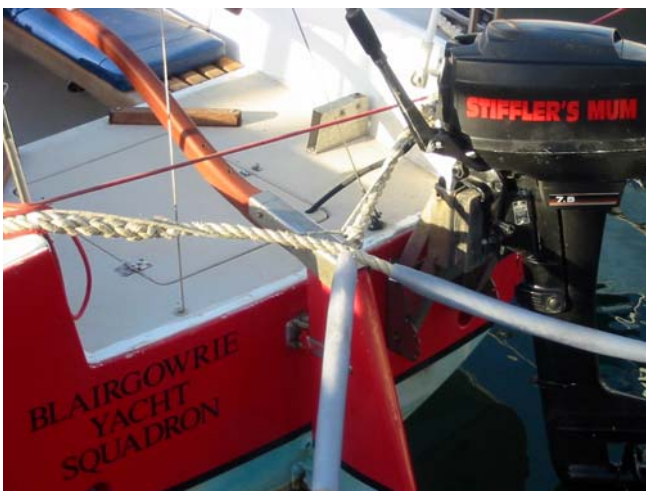
(b) The empty outboard motor bracket on the transom. The motor itself is stowed up forward inside the cabin when racing.

On such yachts, the motor needs to be mounted at the stern for use as shown left on a picture of a motor mounted on a sister vessel. It is impractical however to lift the heavy motor up, carry it back down the cockpit and mount it quickly in a rough sea, in the event of an emergency.

Factor 4.1 (b) because the rudder broke and it was not practicable to mount the auxiliary motor, the crew were unable to effect a man overboard rescue themselves as they had no way to steer the boat back to retrieve Mr Paul.

It is recommended that yachting authorities review the requirements of YA Special Regulations for Category 5 equipment, Section 4.14 which mandates emergency steering for “night sailing” only and Category 6 where it is restricted to “recommended”. Alternatively, an expansion of YA Special Regulations Section 3.23 “Engine and Fuel” could be made requiring “Monohulls” in addition to “Multihulls” to mount outboard motors at all times thus providing an auxiliary steering method. The objective being to allow the vessel a chance of returning back to retrieve a man overboard if he falls over the side when the steering tiller breaks.

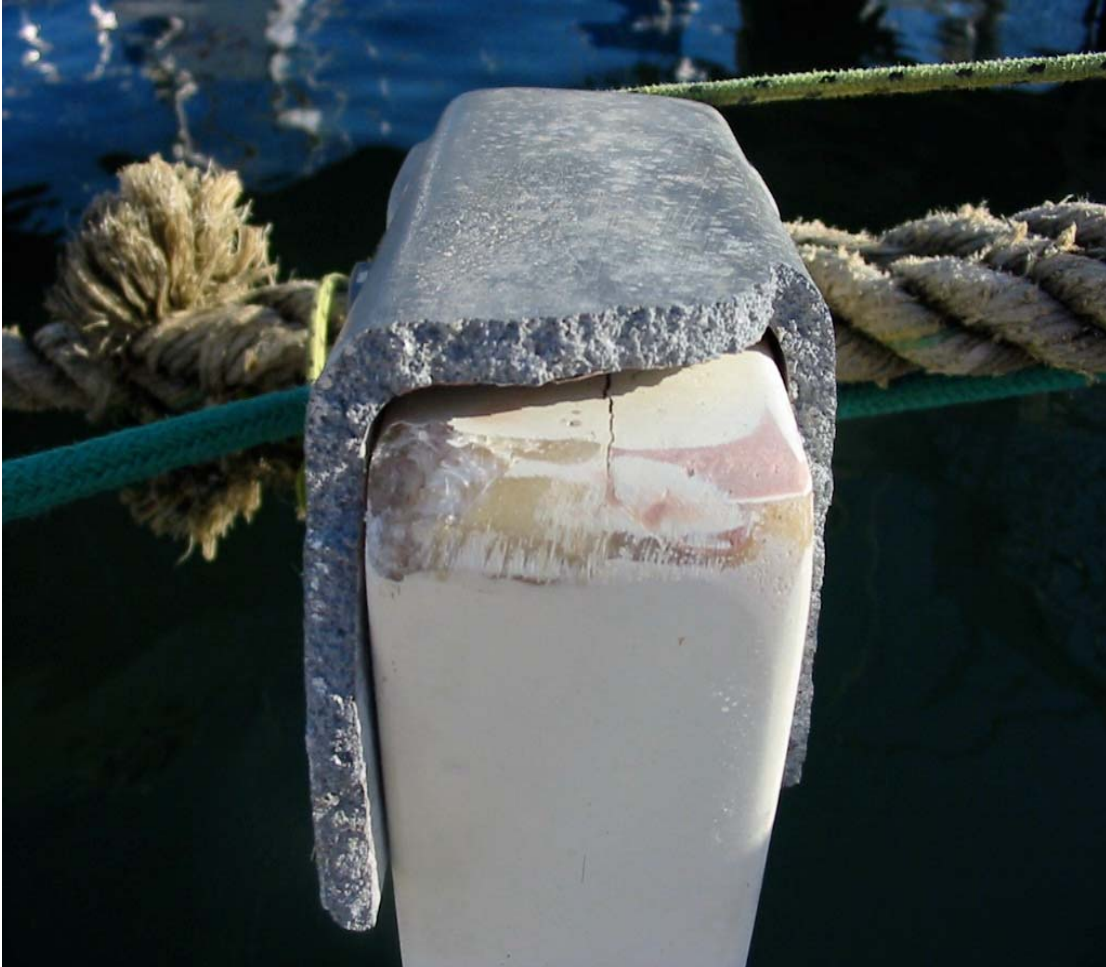
The picture above shows the very grainy structure of the broken cast aluminium rudder head fitting on Adams Den. A fitting of this type would certainly have been under heavy stress at the time of the incident and would need to be at full design strength to eliminate the chance of failure. On close examination this 15 year old fitting does show some hairline cracks behind the broken area, suggesting progressive deterioration over time.

Factor 4.1 (c) the rudder head fitting of the vessel is of a material and construction (cast aluminium alloy) that requires close inspection as it ages because it is susceptible to corrosion and cracking. This can weaken it beyond its ability to withstand original designed loadings, which appears the case in this incident, causing it to fail.

The Adams 10 Class Owners Association has already been contacted by the Water Police investigator with a recommendation they inform all owners to check this fitting, especially on older vessels and replace it if it shows any signs of undue deterioration.

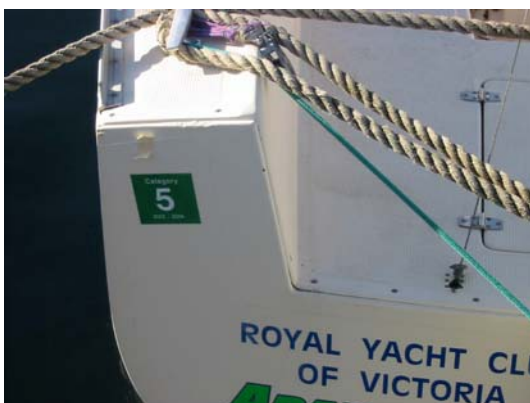
Mr Paul lodged a declaration of compliance for Adams Den of equipment to Yachting Australia Special Regulations Category 5 and was issued with the sticker shown left. (It is noted that the Association Cup race was being run under the lower requirements for Category 6). When examined on 3rd May 2004 a number of deficiencies in the equipment required to be on board and available for use were noted. Some related to Category 5 but some even for Category 6.

Factor 4.1 (d) the vessel could not demonstrate any equipment or method by which crew could be retrieved from the water as required by the Category 6 regulations.

It is recommended that yachting authorities review the requirements of YA Special Regulations Section 4.26 which for Categories 1 to 6, requires “boats to be able to demonstrate equipment or a method by which crew may be retrieved from the water”. It does not provide any more details such as who should this be demonstrated to, how often, what standard should be achieved (i.e. how quickly, under what circumstances etc.).
